DEPARTMENT OF TRANSPORTATION**DIVISION OF ENGINEERING SERVICES**

Contract #: 04-0120F4Cty: SF/ALA Rte: 80 PM: 13.2/13.9File #: 13.28**WELDING INSPECTION REPORT****Resident Engineer:**Pursell, Gary**Address:** 333 Burma Road**City:** Oakland, CA 94607**Report No:** WIR-010222**Date Inspected:** 18-Nov-2009**Project Name:** SAS Superstructure**OSM Arrival Time:** 700**Prime Contractor:** American Bridge/Fluor Enterprises, a JV**OSM Departure Time:** 1530**Contractor:** Oregon Iron Works Clackamas, Or.**Location:** Clackamas, OR**CWI Name:** Mike Gregson, Jose Salazar**CWI Present:** Yes No**Inspected CWI report:** Yes No N/A**Rod Oven in Use:** Yes No N/A**Electrode to specification:** Yes No N/A**Weld Procedures Followed:** Yes No N/A**Qualified Welders:** Yes No N/A**Verified Joint Fit-up:** Yes No N/A**Approved Drawings:** Yes No N/A**Approved WPS:** Yes No N/A**Delayed / Cancelled:** Yes No N/A**Bridge No:** 34-0006**Component:** Hinge K Pipe Beams**Summary of Items Observed:**

Hinge-K Pipe Beam Fuse Assembly 120A-2: 11/18/09

Hinge-K Pipe Beam Fuse Assembly 120A-1: 11/18/09

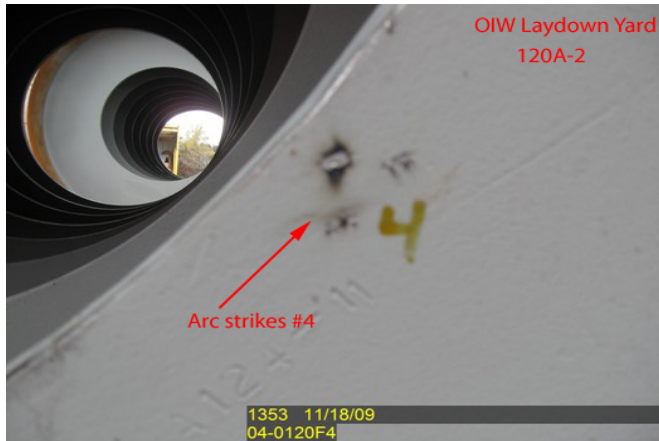
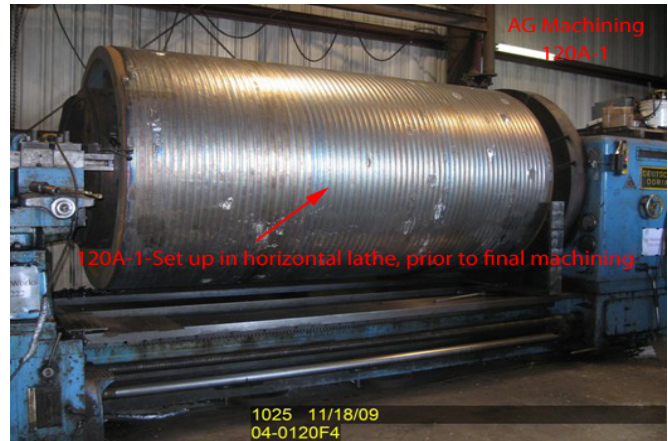
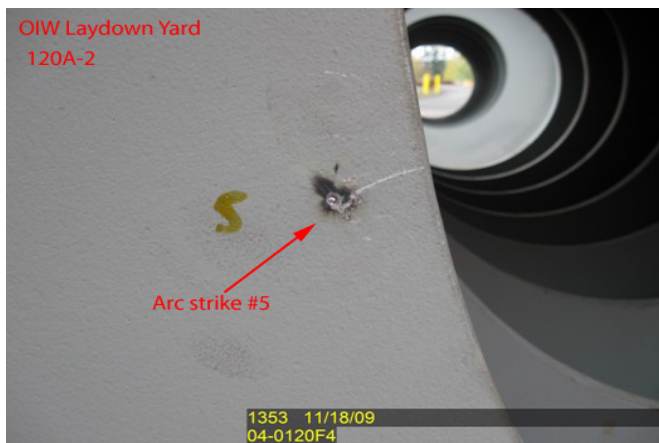
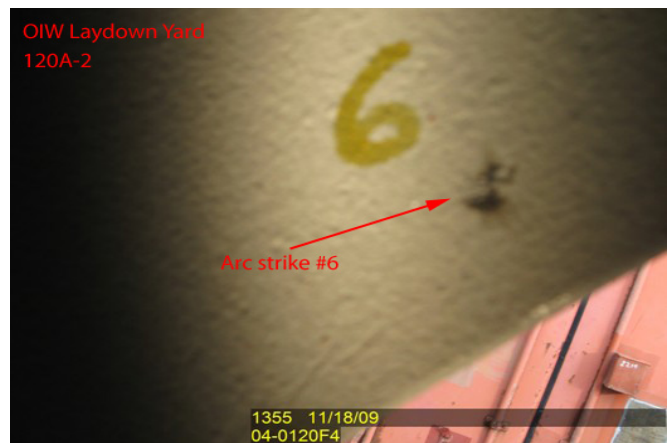
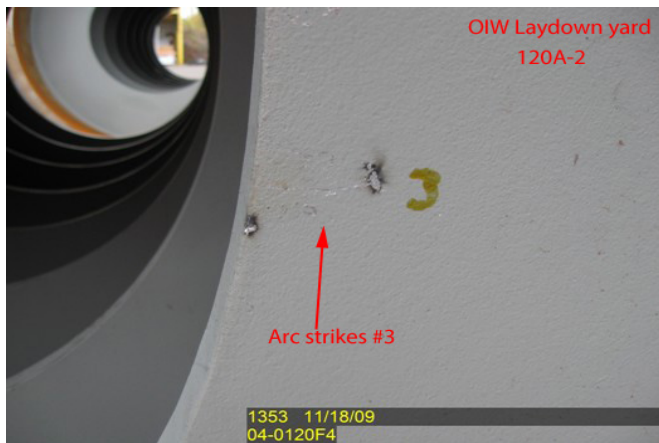
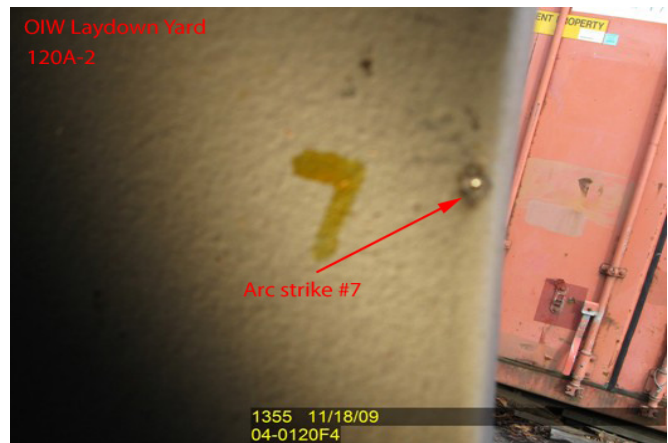
QA Inspector spoke with Lead QA Inspector Joe Adame and Mr. Adame had explained that arc strikes were noticeably present on the internal ring stiffener (a124-11), on fuse assembly 120A-2. Mr. Adame explained that the arc strikes were probably caused by the welder not being able to achieve a sufficient ground through the zinc primer coat, during the TIG weld repairs, which were previously performed by OIW, at AG Machine shop, on the exterior stainless steel overlay. Mr. Adame explained that an e-mail was sent out, with pictures and OIW production/QC was notified of the arc strikes and that corrective action should be taken in the future, to avoid the arc striking problem. Mr. Adame also stated that the arc strikes will need base metal repairs/repainting and also the

areas where the internal chucks had been present, during the machining process. QA Inspector took photographs of the above mentioned arc strikes, as shown above.
